Burton Bradstock Parish council – Rights of way and access issues

Brief: A review of access issues on the frequently used footpaths within the village. Initially included in the PC agenda following concerns regarding the footpath adjacent to Larkfield discussed in a previous PC meeting.

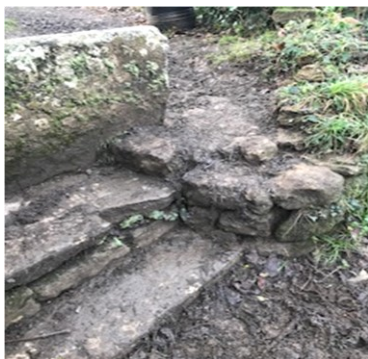
Footpath adjacent to Larkfield Caravan Park – Stone steps at the northern end of the path are damaged and uneven. The public generally walk to the western edge of the stone stile and the gap is narrow (pic 1) This area needs improvement as a trip or fall on these steps is very likely.

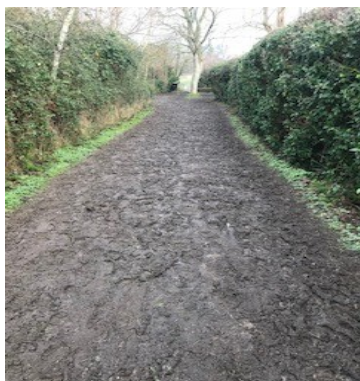
The footpath surface between the stone stiles gets extremely muddy in winter months as this is a very well used footpath that would benefit from a covering of chipped wood/bark or alike (pic2)

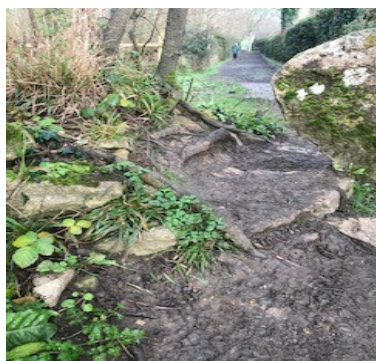
The access at the southern end onto common lane also has considerable trip hazards caused by the uneven surface and tree roots in the gap adjacent to the stone stile. The small trees/bushes need cutting back and the roots removed (pic 3)

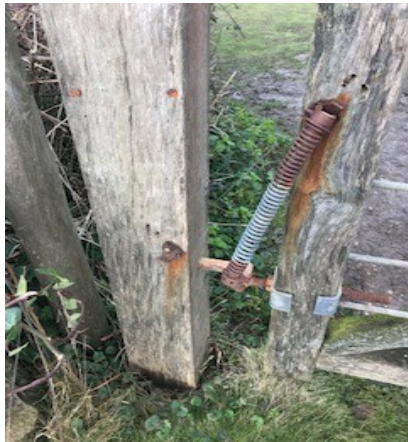
The first gate from the field east of Hive Beach cafe onto the cliff path has a broken closer (pic 4)

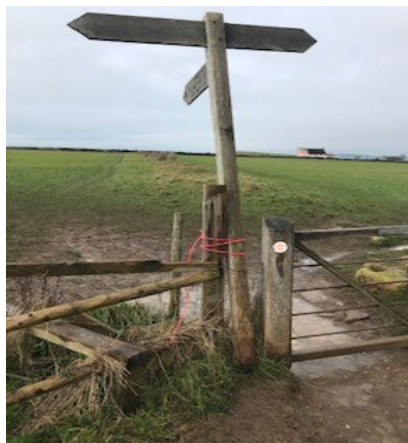
In general the footpath from the car park behind Barton Oliver is well used and extremely muddy. It would benefit from chipped wood/bark covering. The has a footpath sign by the middle gate is broken and dangerous (pic 5)

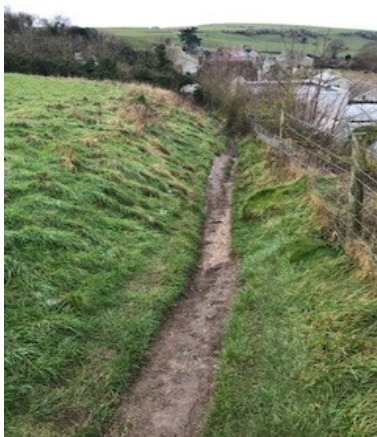
The access behind Burton Bradstock Cars is extremely hazardous and a gulley has formed causing a serious trip hazard (pic 6)

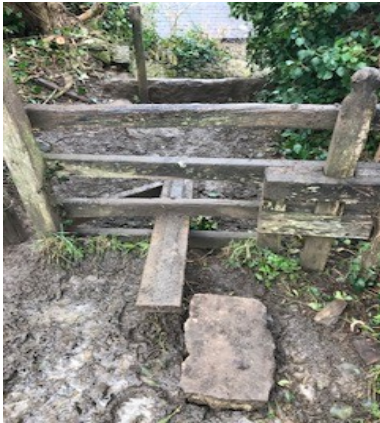
The stile is secure but a large loose stone required to cross needs securing (pic 7)

The area between it and the stone stile is eroded and fills with water so could be improved.

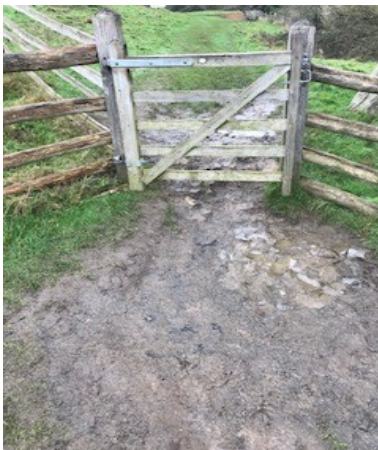
The area through the gate in the middle of the field has eroded and exposed large stones that are a trip hazard (pic 8)

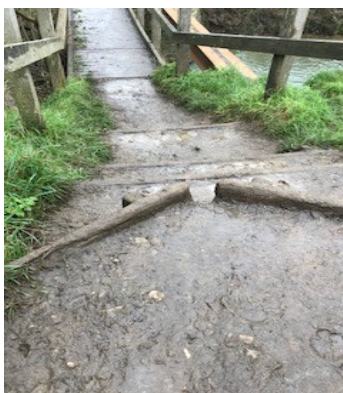
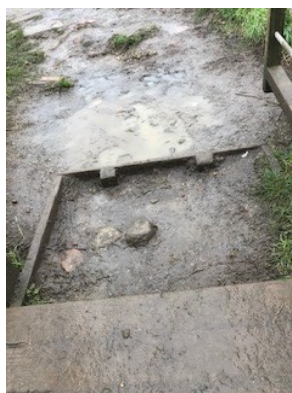
Both ends of the bridge across the river are also eroded and contain trip hazards (pics 9 & 10)

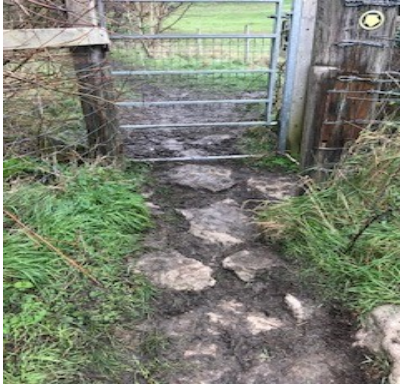
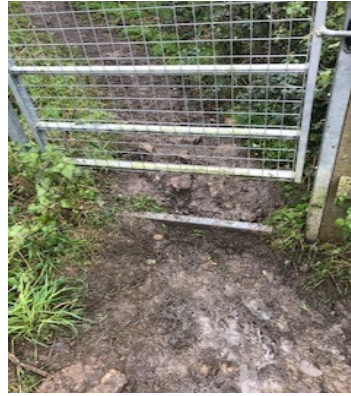
Metal access gates on both ends of the path as it crosses at the end of Manor Farm show signs of wear and contain trip hazards (pics 11 & 12)

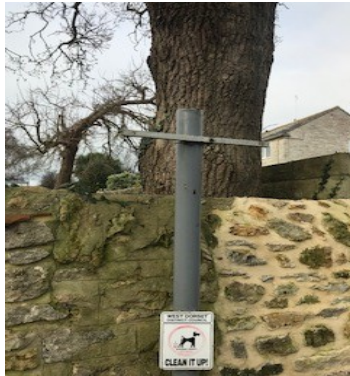
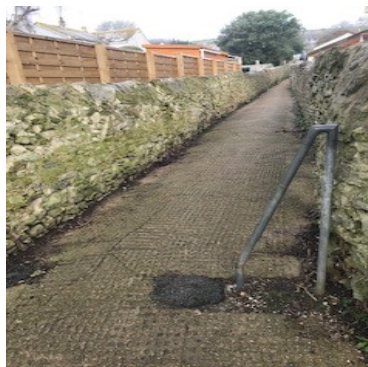
There is a footpath sign missing at the lower end and the remaining section of barrier that was considered to be supporting the wall is a hazard in the dark and I feel not supporting the wall. (pics 13 & 14)

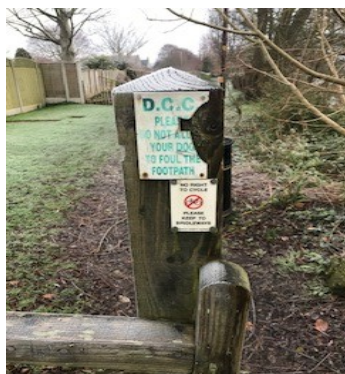
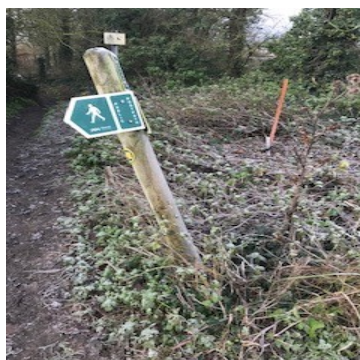
There is a damaged sign at the east end of Grove Road and the sign post at the Arch Bridge end needs some attention (pics 15 & 16)

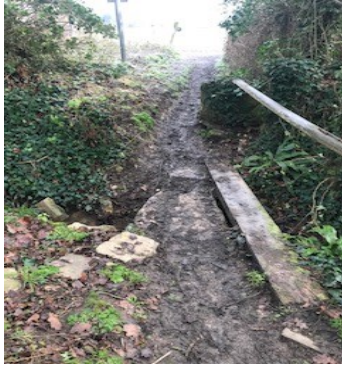
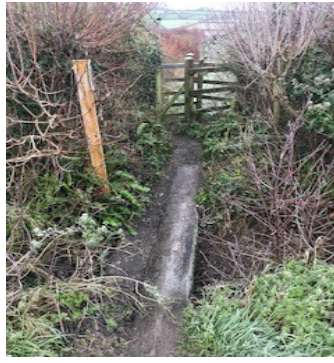
The accesses across the ditches at both the Arch Bridge end and onto Bredy Road are narrow and slippery in the winter months. These also get very overgrown in the summer months (pics 17 & 18)

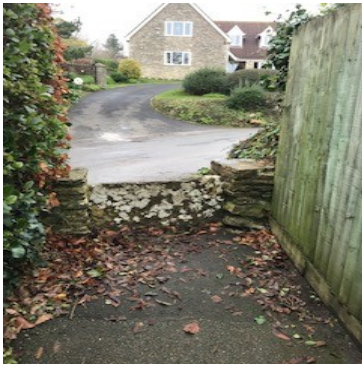
The stone stile at the top of the path as it enters Shipton Lane is an obvious obstruction for buggies etc, but there is little that can be done. However this is a blind access onto a fairly busy lane and some signage may benefit users (pic 19)
